ESSEX-WINDSOR SOLID WASTE
AUTHORITY

Essex Landfill Site No. 2
2008 - 2009
BIENNIAL OPERATIONS
REPORT

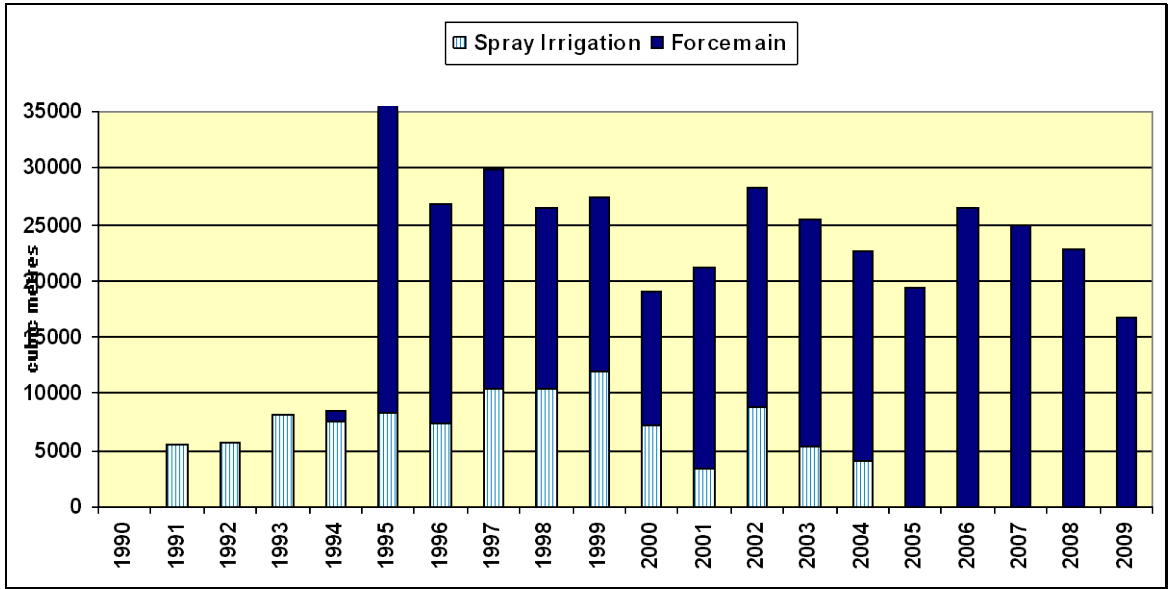
FIGURE 1: HISTORICAL DATA OF LEACHATE QUANTITIES 1990-2009

The quantity of leachate captured in 2008 and 2009 is consistent with recent historical rates, as shown in Figures 1 and 2.

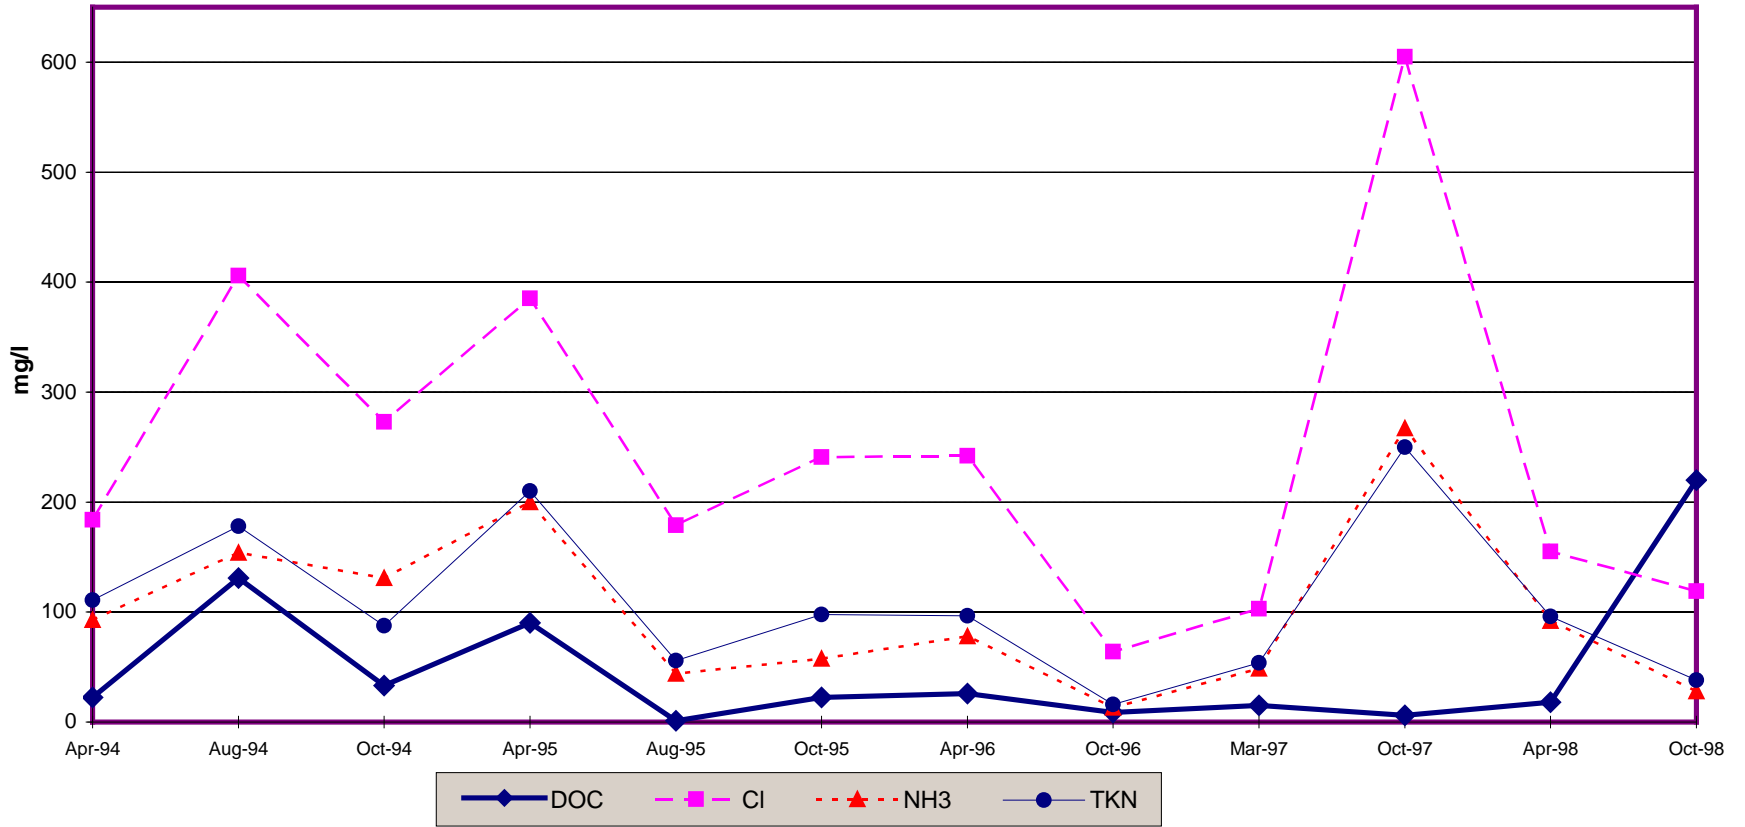
Leachate Analysis for Manhole 7 (MH7)

The analytical results for 2008 and 2009 are shown in Table 1, and Appendix B. In summary, the chemical concentrations are typical of old leachate from municipal solid waste landfills in southern Ontario. Similar to the historic chemical results, in 2009 the leachate collected in the eastern portion of the collector system (MH6) is diluted by ground water and/or infiltration of precipitation, but contains elevated concentrations of vinyl chloride. Samples could not be obtained from MH8 for April and October 2009 due to insufficient volume recovery.
